# RIVER ROCK AND FIELDSTONE BOULDERS ON THE PRAIRIES

stories from an architectural practice

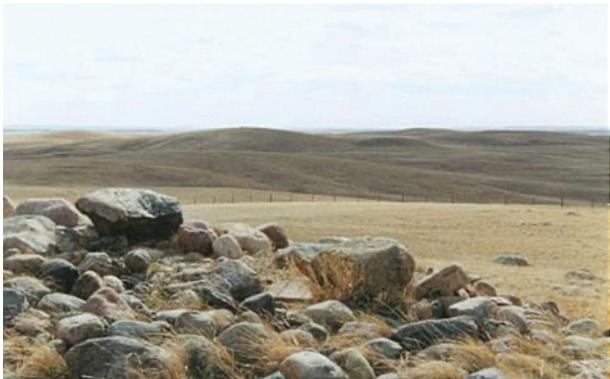
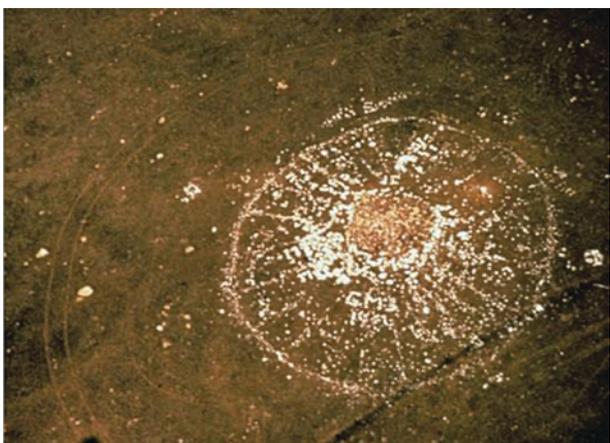
: the cairn at the centre of the Majorville Medicine Wheel

: aerial view of the whole Majorville Medicine Wheel. What might be considered vandalism in the initials and dates seen from the air, is a possible continuation of medicine wheel use.

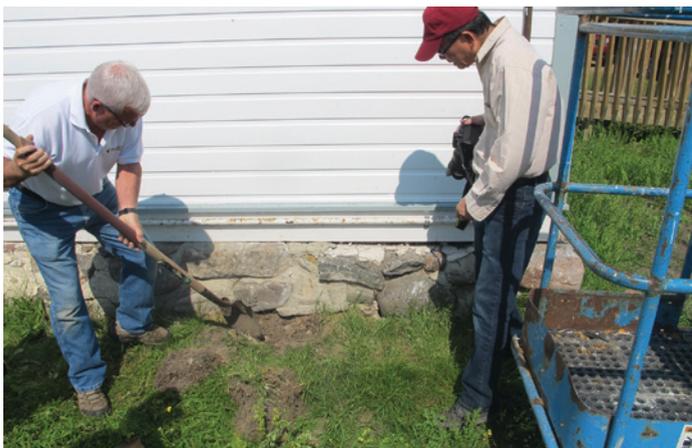
Testing the depth of the foundation wall and the soil it rests upon. The Lac La Biche Church foundation, before and after restoration

In 2012, I prepared a conservation plan for the entire Lac la Biche Mission site for a Parks Canada-funded conservation study. In the report, I noted that the church's shallow stone foundations, rebuilt after a 1921 tornado, were severely out of alignment and had deteriorated after years of winter frost heave.

Lac La Biche Mission is a designated and protected Provincial and National Historic Site. In consultation with a provincial heritage advisor, it was determined that the most appropriate form of conservation would be to completely restore the uncut stone foundation *in situ*, using the original stones and lime-based mortar materials, with a small amount of cement added to the lime mortar mix to increase durability.<sup>3</sup>

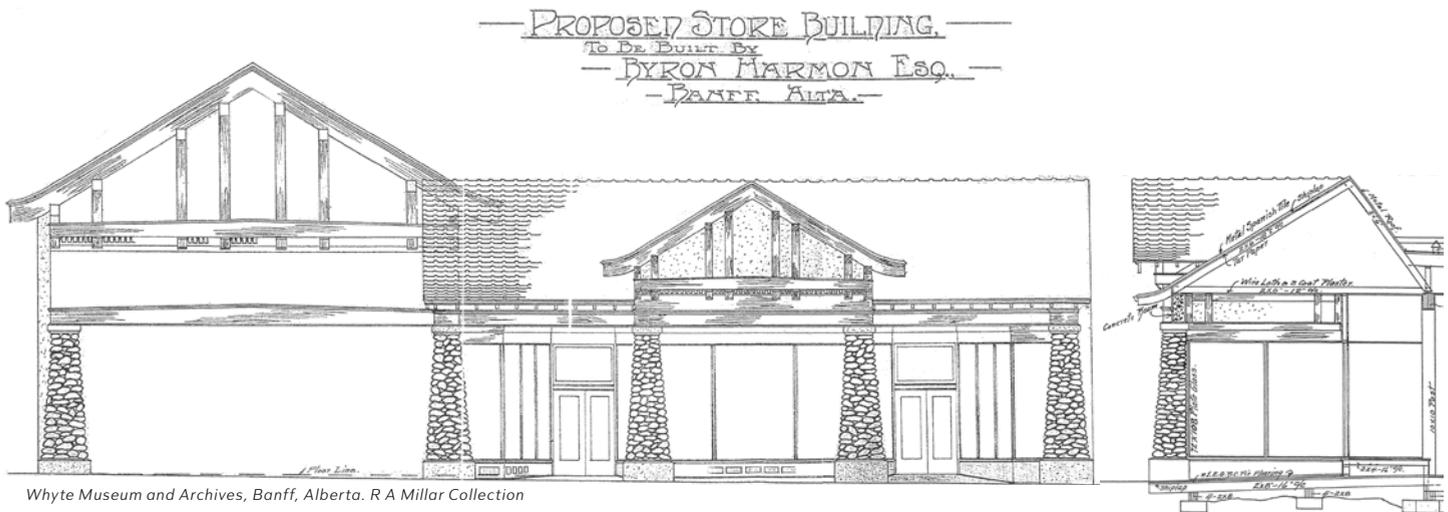
above: the street elevation of the Harmon Building, and above left: a section through the wing. These working drawings were prepared for Byron Harmon by Calgary CPR architect, R A Millar. The original 1914 building, with the 5 structural field stone columns along the facade, was constructed by Byron Harmon as a movie theatre and designed by Chicago architect Harvey Wright. When the theatre burned down in January 1917, right, the structural stone columns across the front were the only part left standing. By July 1917, part of Millar's design for the new building had been built and occupied; the rest of the building was completed by 1920

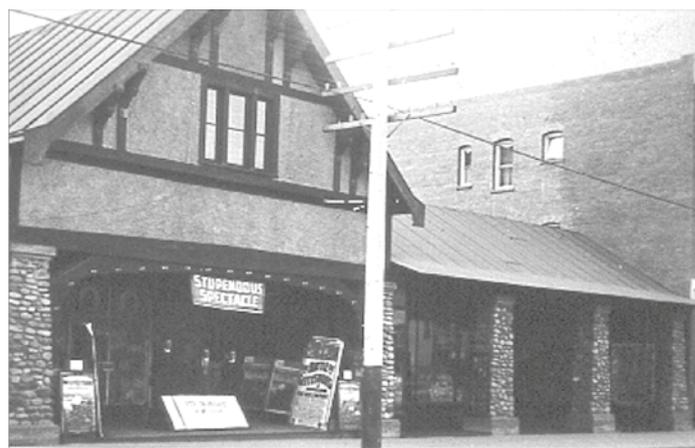
below right: Banff Avenue and the Harmon Building after restoration in 2004

In 2001, I was engaged to prepare a conservation plan for the restoration and repair of the historic facade of the Harmon Building, known as Harmony Lane, at 111 Banff Avenue in Banff, Alberta. This is a remarkable building completed in 1920 by the famous mountain photographer, promoter and entrepreneur Byron Harmon.

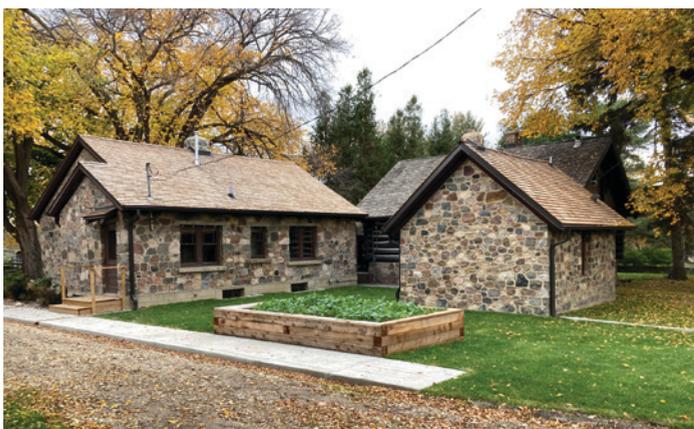
The scope of this project is seen in the completed restoration in 2024. The Stone House is on the left, the Summer Kitchen, attached to the log cabin, seen behind it, is on the right.

In both buildings the foundations had failed causing severe deterioration of the solid stone walls. The foundations of both needed to be replaced before the stone walls could be repaired. The Stone House was lifted *in situ* and a new concrete basement constructed underneath. Unlike the Stone House, the Summer Kitchen was in worse shape and had to be completely dismantled in order to lay a new supporting concrete slab on grade.

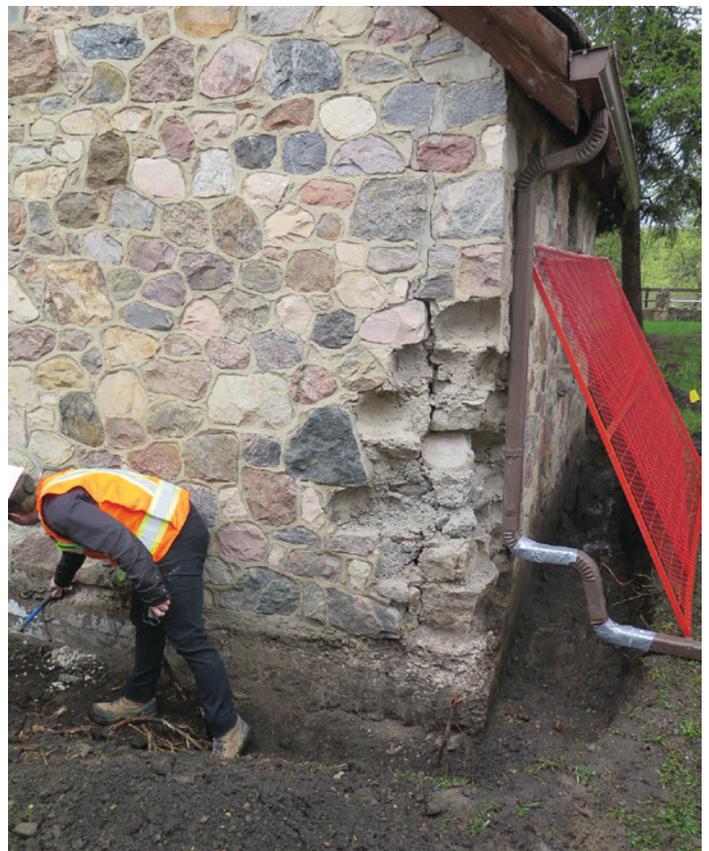
The failure of the Summer Kitchen 1929 foundation meant that the stone walls had started to collapse. Complete re-building was necessary.

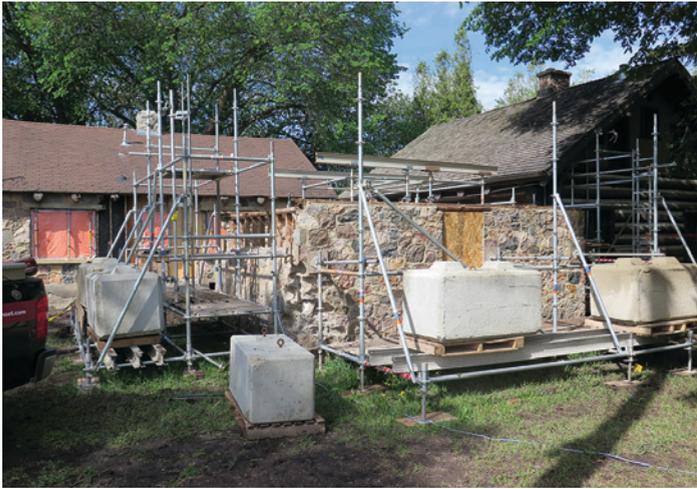
The kitchen was documented in photos and drawings and the roof was removed intact before the stone walls were dismantled. All materials were saved and stored for reconstruction. The roof was repaired and then re-attached when the walls were complete.

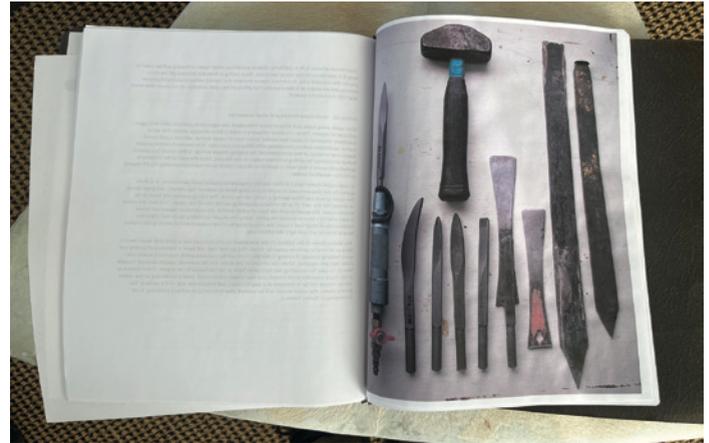
A page from Scorpio's manual on Masonry Restoration showing their traditional stonework tools.

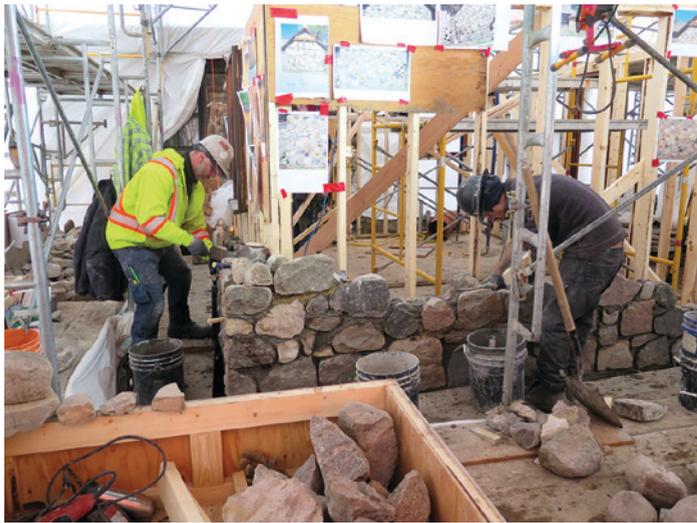
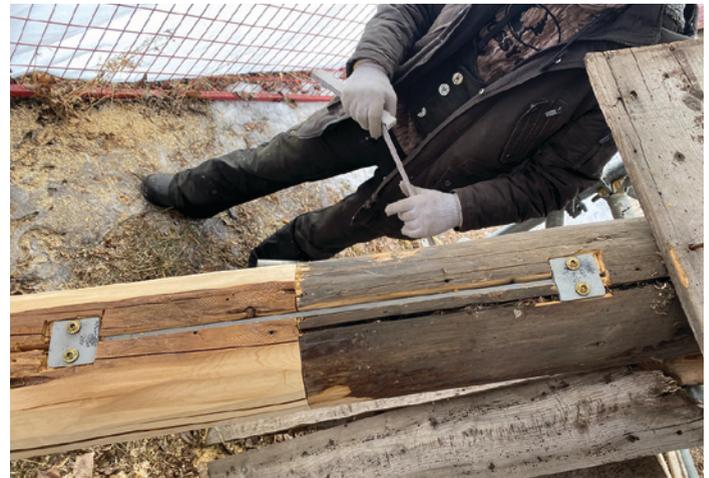
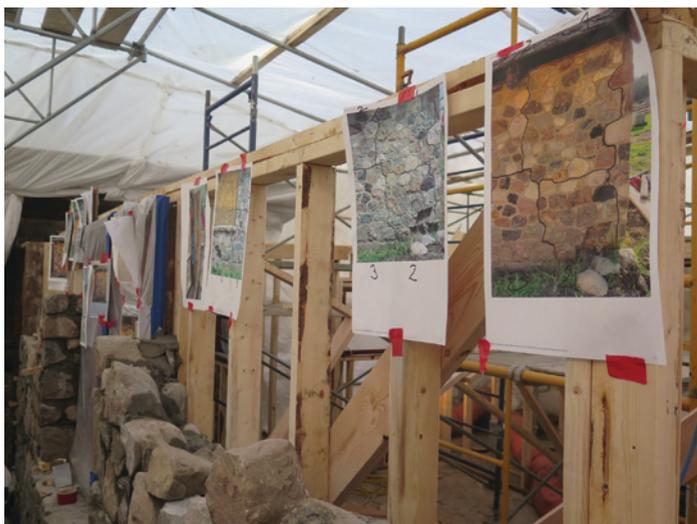
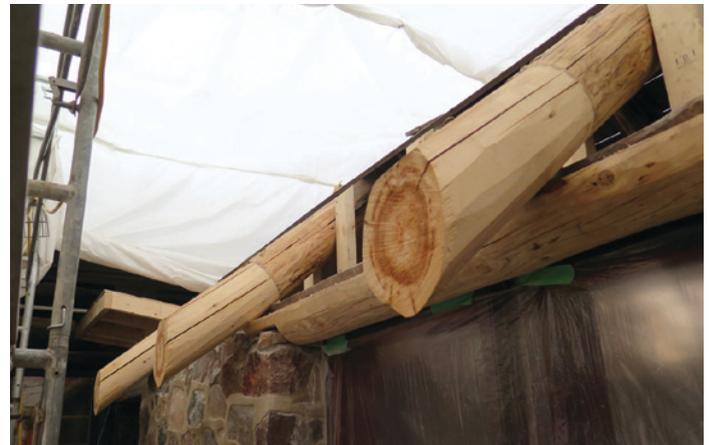
above: large photographs of the original walls were the guide for the exact re-laying of the original field stones! The new framing replaces the original interior partitions and the lining of the stone walls.

*middle right:* all the log ends for both the Stone House and the Summer Kitchen were replaced and fitted into the original log rafters.

*right:* in the completed reconstruction of the Summer Kitchen a new at-grade concrete foundation was constructed, and replacement interior partitions were built before the stone walls were rebuilt. The weathered log ends were all replaced and finally the repaired original roof was re-attached.

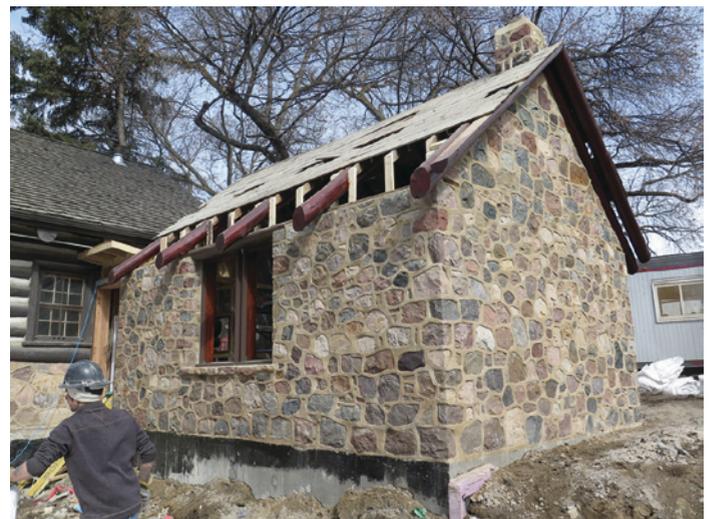
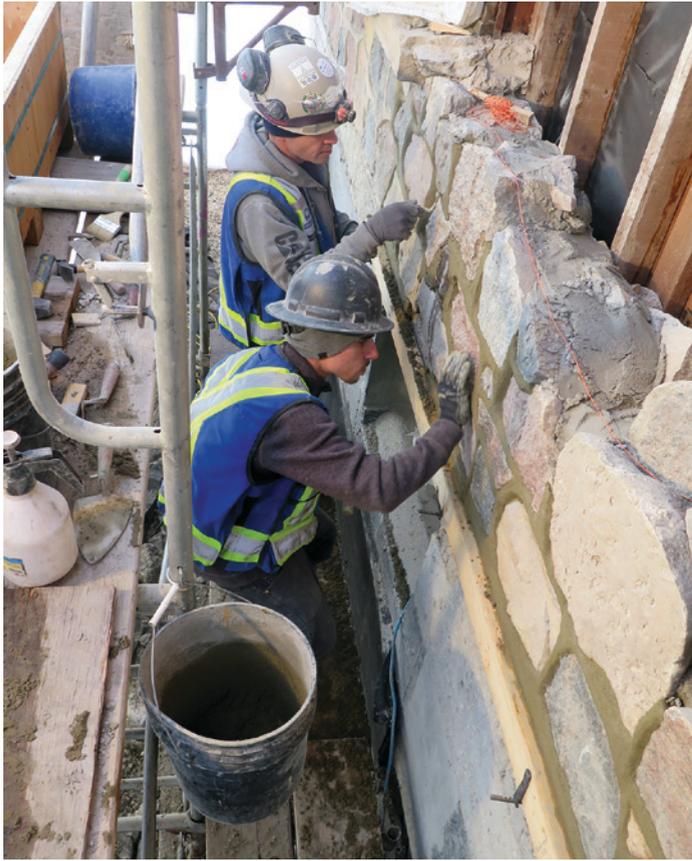
Skilled Scorpio Masonry stonemasons rebuild the walls exactly as the documentation before de-construction indicates.

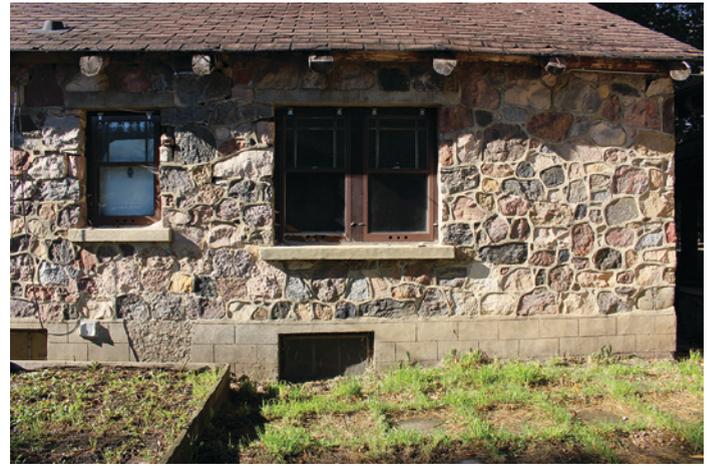
Photographic documentation of the stonework was important to the restoration. The left side of this photo of the Stone House shows the deteriorated stonework (compared to the right hand side of this wall, due to the failing foundation).

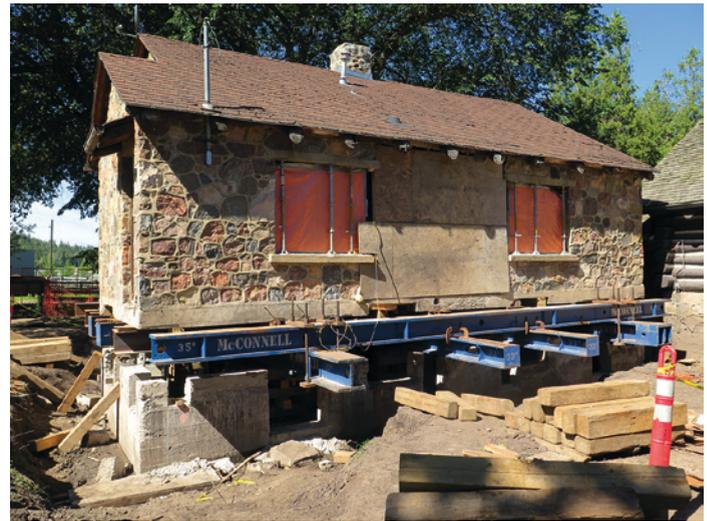
A new, deeper, more functional basement was constructed under the Stone House. The process is that the building was set on girders and lifted *in situ*, and the basement build underneath. The deteriorated stone work was then repaired.
